No Further Action Determination Request

Former Automotive Salvage Site
Project Cactus: Silverlake Distribution Warehouse
819 West Silverlake Road and 780 West El Puente Lane
Tucson, Pima County, Arizona

ADEQ VRP Site Code: 513208-00
VRP 19-207

June 12, 2019
Terracon Project No. 63187190

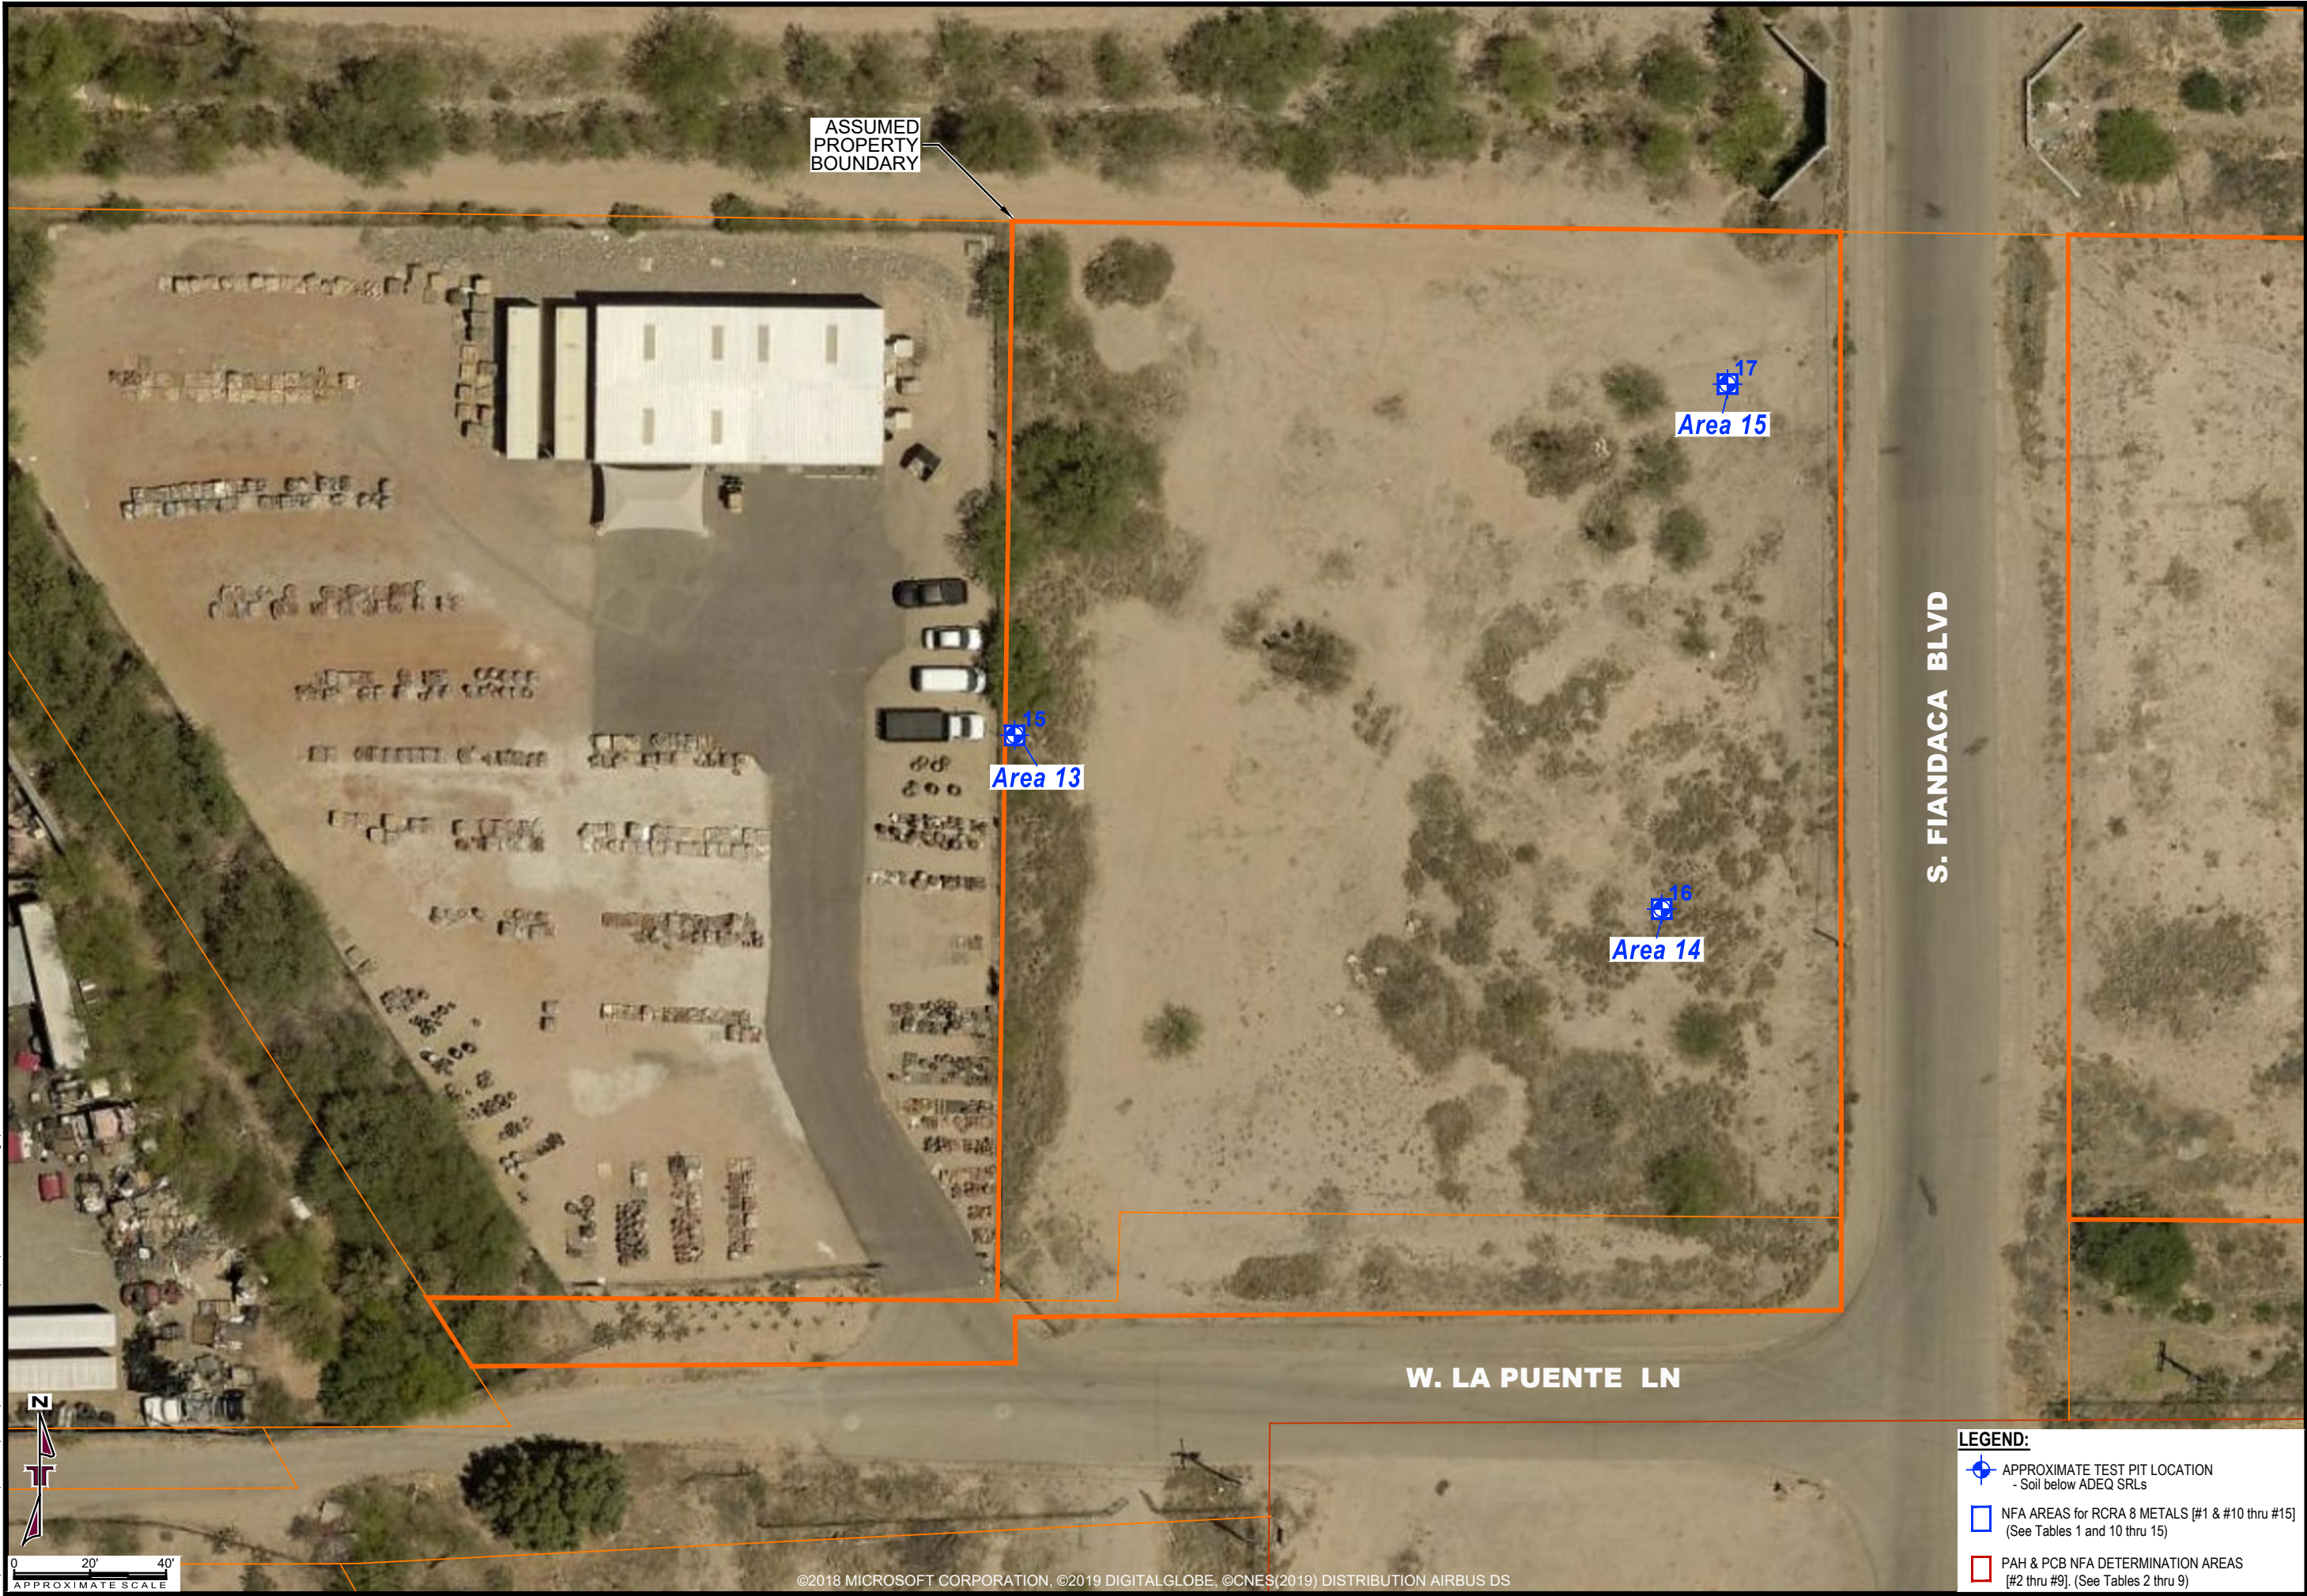
Project Mgr:	DDK	Project No.:	63187190	Scale:	as shown	Exhibit	3
	Drawn By:		KLJ				
Checked By:	DDK/JT	File No.:	63187190_rev.dwg	Project Cactus		819 West Silverlake Road and 780 West El Puente Lane	
Approved By:	DMM	Date:	06/07/2019	Tucson, Arizona

APPROXIMATE TEST PIT LOCATION - Soil below ADEQ SRLs

NFA AREAS for RCRA 8 METALS [#1 & #10 thru #15] (See Tables 1 and 10 thru 15)

The boundaries for the NFA Request are provided in Exhibits 2 through 4, Appendix A. Summaries of analytical data to support the NFA determination compared to applicable ADEQ rSRLs and GPLs is provided in Tables 1.1 through 15.1, Appendix B.
